Concrete India

Repair and Restoration of Maker Chamber VI, Nariman Point

Shreeji Heights Parking Garage Repair & Podium Waterproofing Rehabilitation

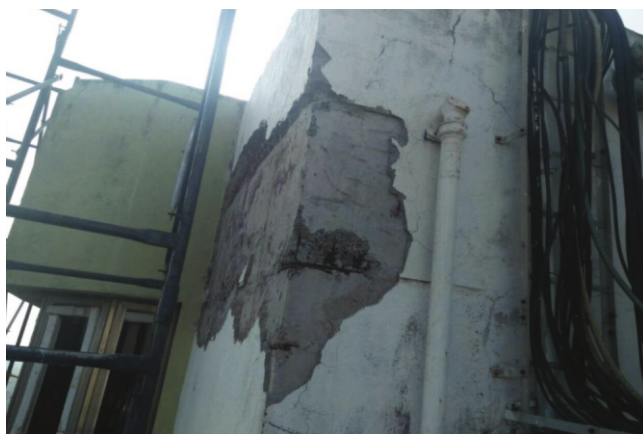
Fig 3 Above & Fig 4 Below: Test Results depicting deterioration in Concrete façade elements and canopies

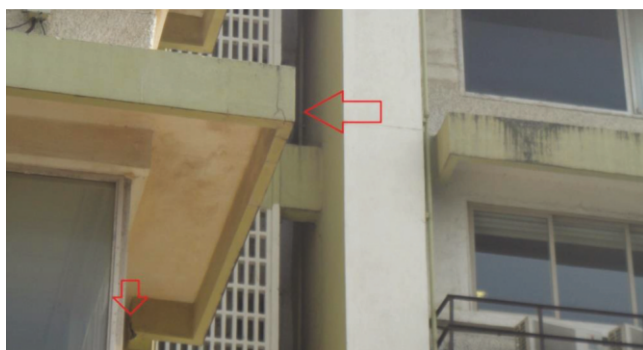
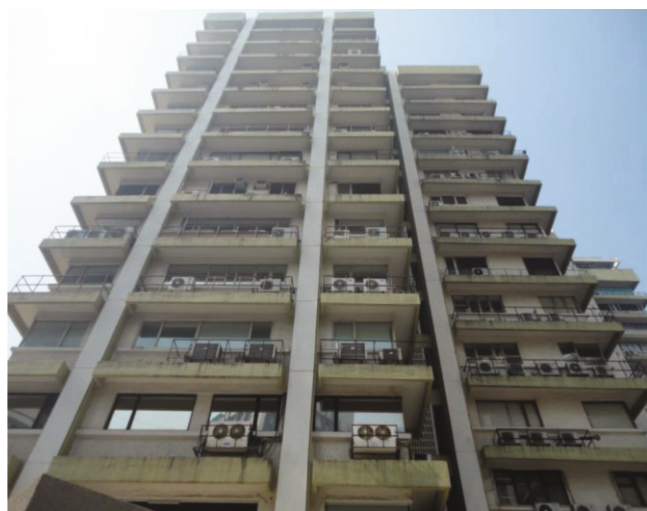
Fig 1: Building external conditions depicting damage in concrete elements

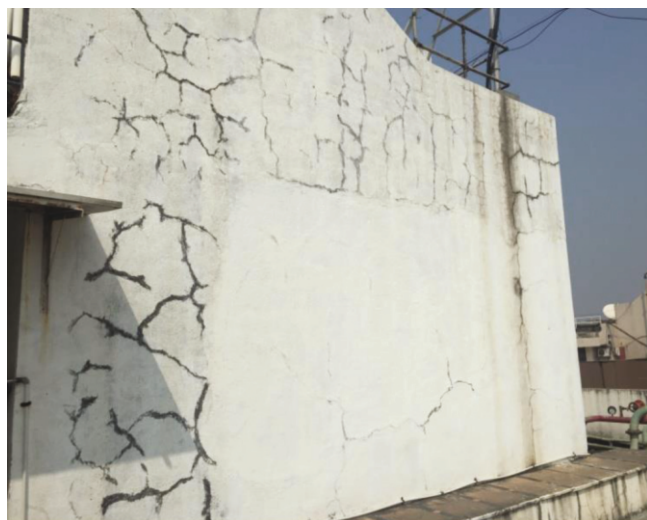
Fig 2: Delamination of façade render with corrosion induced macro cracks deterioration of the structure.

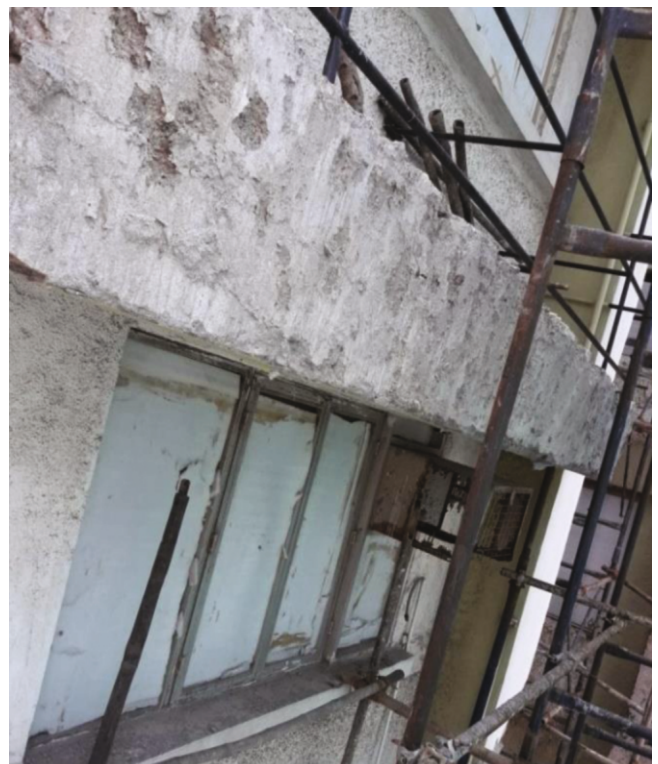
Fig 6: Chipping of damaged external plaster

3. The existing cement mortar rendering on the external walls was carefully removed without undue damage. The deteriorated concrete was removed with 15 lb (6.8 kg) chipping hammers and sandblasting corroded reinforcing steel. Exposed steel was coated with a corrosion inhibitor with added admixture to the repair mortar. The exposed corrosion-inflicted reinforcing steel was cleaned with a pre-treatment to loosen the rust scales and passivated against corrosion with epoxy-based formulations.

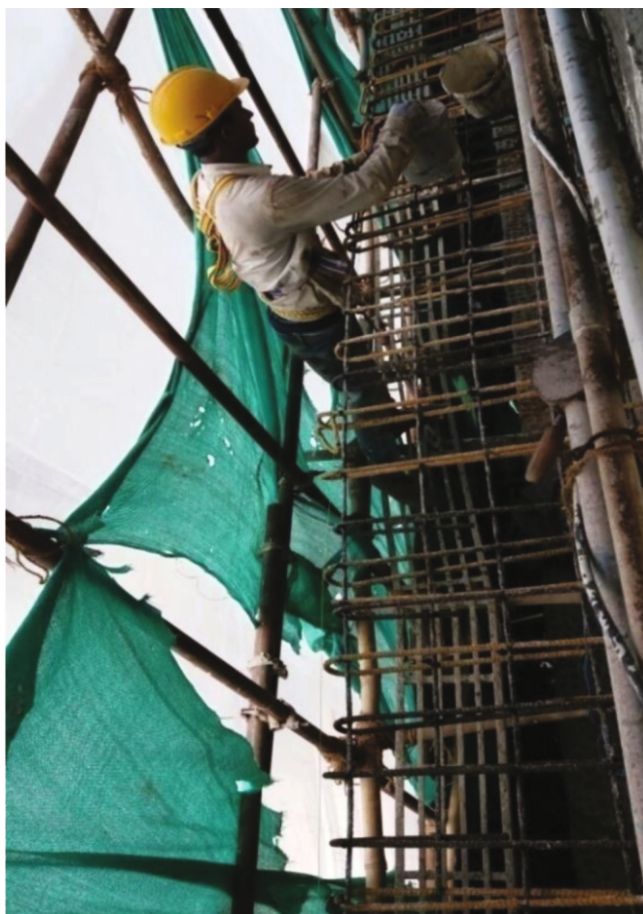
Fig 7: Repair/Replacement of Reinforcement bars.

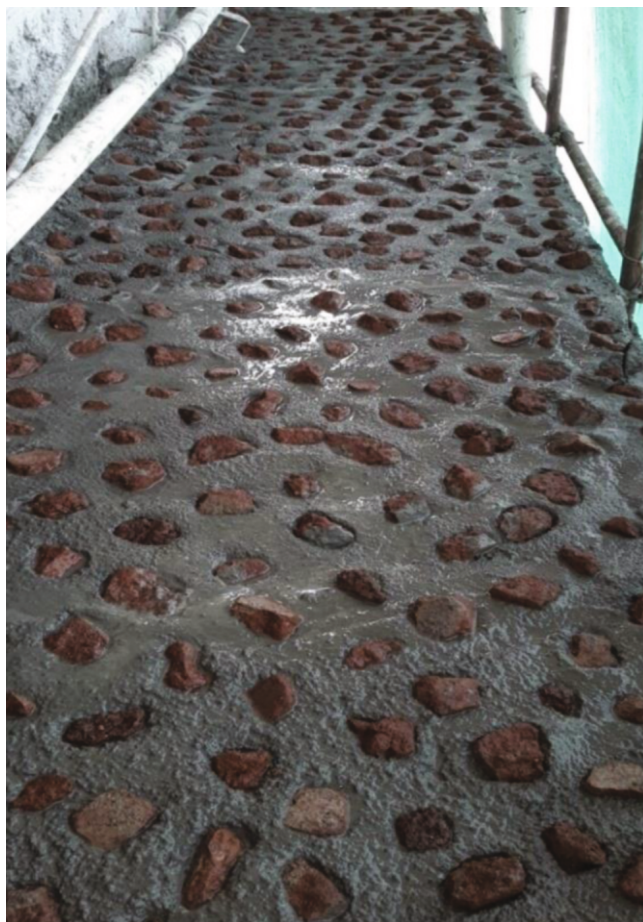
Fig 8: Casting of new concrete with thermal insulation & waterproofing on canopies and drop pardi

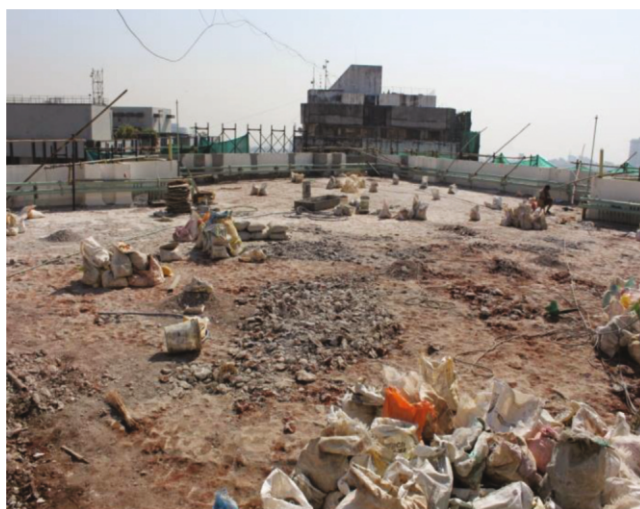
Fig 11: Removal of damaged concrete flooring till the old slab

The entire flooring surface of the terrace was removed till the slab and was then covered by a rich cement slurry, followed by a layer of mortar with a ratio of 1:5 cement: sand. Brickbat pieces were laid on the mortar to serve as thermal insulation to absorb heat from the direct sunlight that reached temperatures of 120 °F (50 °C). These pieces also served as keys for the subsequent waterproofing screeding, which was float-finished. Care was taken to ensure correct detailing, especially at the joints of the old slab and the newly laid mortar. A haunch made of brick pieces was sealed with hand-packed brick aggregate fixed in mortar so that the joints would not open up. A subsequent layer of render was laid over and above the haunch to ensure that water would not penetrate

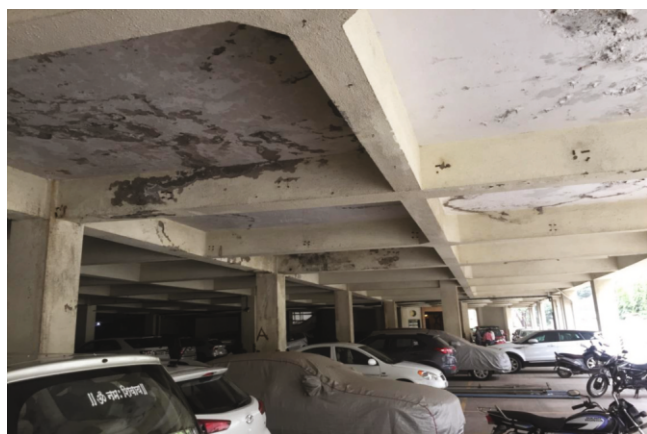
Fig 1: Deteriorated concrete with exposed reinforcement bar due to severe water leakages from the top.

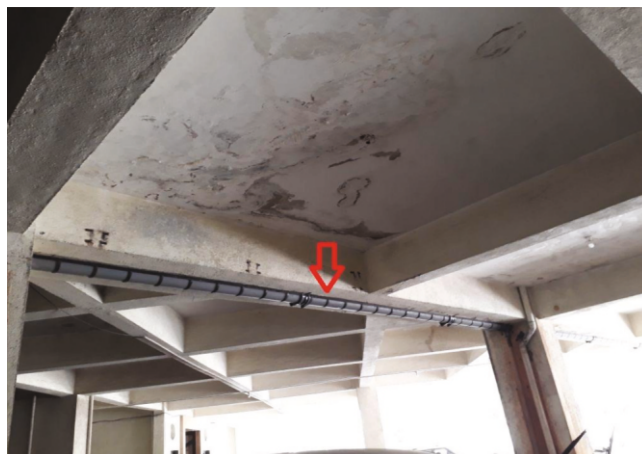
Fig 2: Leakages coming from the expansion joint collected in drain outlet pipes as a temporary solution.

Since, the expansion joints had rendered rigid due to cement mortar/concrete/soil-topping fills leading to stress build up in adjacent beams/columns/brackets which not only led to severe cracking in these structural members but also had a bearing on the stability of building structure. Also, cursory inspection of expansion joints at some locations indicated that the filler material in the joints has lost its efficacy as the material inserted was fully eroded. Apart from resulting in a loss of movement accommodation capacity of the joints, the joints had become vulnerable to leakages below.

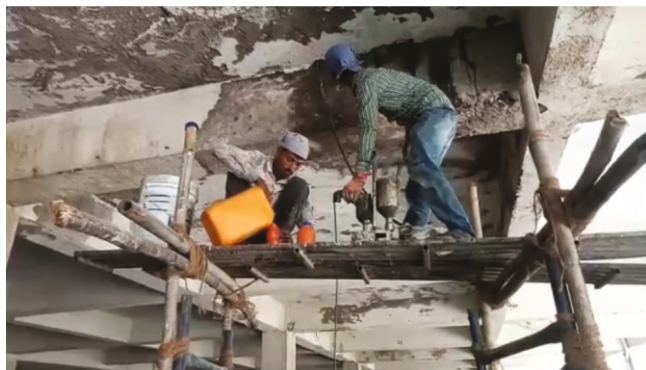
Fig 6: During drilling nozzles and injecting resin grouts followed by Polyurethane foam grouts.

Treatment: The work was commenced by first identifying the wet areas and then drilling in those leaking areas to carefully fix nozzles (alloy packers - non return type) @ cracks using suitable drill machine at least 75-100mm in depth (With dia of 16mm -20mm) and sealing the nozzles. After sealing the nozzles, single component polyurethane injection foam was injected through high pressure pump to accelerate reaction in moist surrounding & stop water ingress. After a short break, a low viscosity 3 component injection resin grouts based on vinyl ester methacrylate technology was injected with one component pump to plug leakages and avoid blockages. The above material were carefully emptied, mixed and pressured by means of a mechanically piston driven high pressure injection pump to plug active water leaks in concrete & masonry which gave best result whenever it got in contact with leaking water as it increases its volume. The entire procedure was repeated until the crack was completely filled and the resin was seen emerging from the adjacent packers/holes.

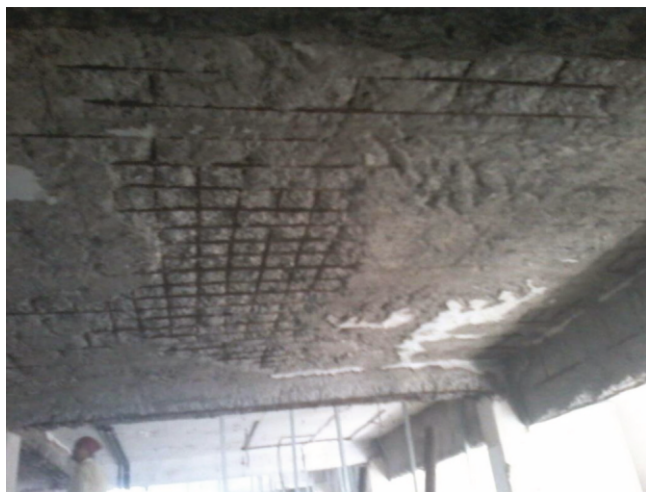
Fig 8: During the repairs of deteriorated concrete

- a) The existing damaged ceilings of the garage were carefully removed without undue damage. The deteriorated concrete was removed with 15 lb (6.8 kg) chipping hammers and sandblasting corroded reinforcing steel. Exposed steel was coated with a corrosion inhibitor with added admixture to the repair mortar. The exposed corrosion-inflicted reinforcing steel was cleaned with a pre-treatment to loosen the rust scales and passivated against corrosion with epoxy-based formulations.
- b) The RCC Beams on both side of expansion joints were
