Concrete India

Repair and Restoration of Maker Chamber VI, Nariman Point

Shreeji Heights Parking Garage Repair & Podium Waterproofing Rehabilitation

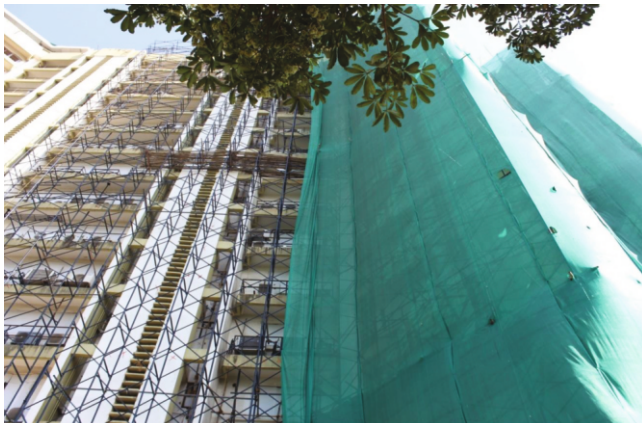
Fig 5: Tubular Scaffolding with arresting safety nets and platforms for safe working conditions with complete glass window covering.

1. Tubular steel scaffolds were carefully erected at calculated

heights for lateral stability. The entire scaffolding was covered with protective hessian cloth to arrest any falling debris during repairs. Working at such height was very challenging and risk to one's life. Hence, working platforms at convenient locations were erected to facilitate safe working conditions with faster progress.

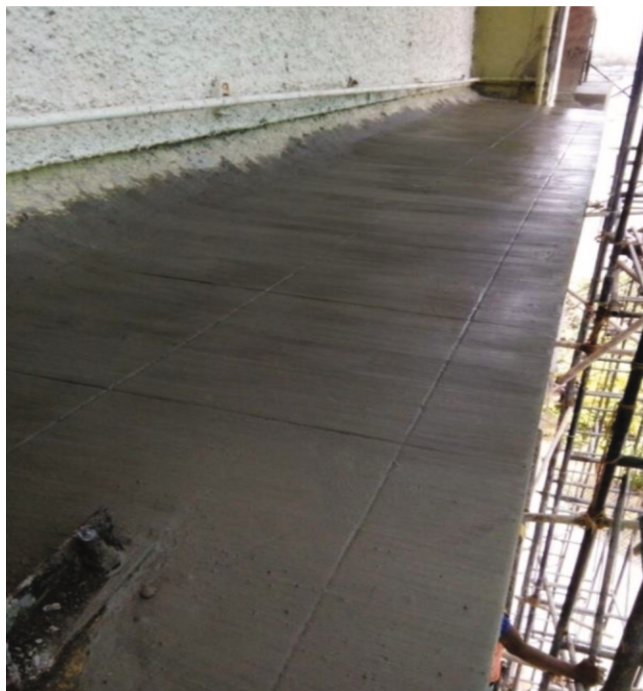
Fig 9: Final finish of new concrete with false checkered lines to minimise cracking.

11. The concrete layer was cured for 10 days by continuous wetting through a sprinkler system created especially for this purpose and was then rendered with cement mortar overlays in two coats with a sponge textured finish. To achieve waterproofing and thermal insulation of the top of box sections, a layer consisting of small brick pieces (as thermal insulation) fixed in cement mortar bedding was first laid with the correct slope and then overlaid with a jointless screed coat with polymer-modified rich cement float, finished with false checkered lines to minimize map cracking and shrinkage.

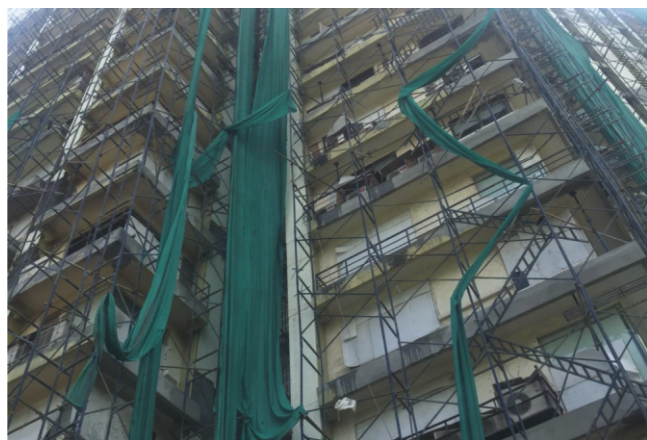
Fig 10: After image of repaired shear wall plaster & new constructed concrete canopy and drop pardi.

7. The shear walls were treated with high performance ready mix cement plaster which had in mixed high quality polymer additives with well graded sand & fillers. It gave an excellent finish after its application in two coats of upto 25 mm thick with negligible wastage on site and met the required technical parameters of the engineer with com-

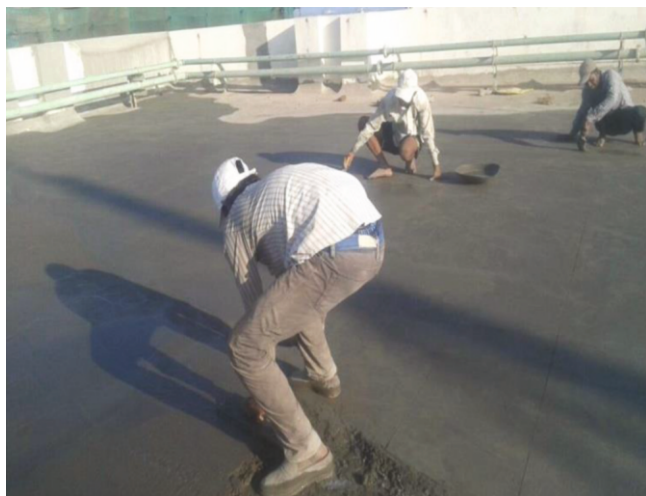
Fig 12: Laying of new concrete mortar with waterproofing finish on top section.

through. The flooring was finished with false checkered lines to minimize map cracking. A wearing coat of 600% elongation single component polyurethane coating was applied on the entire terrace to make it cool roof and leak free.

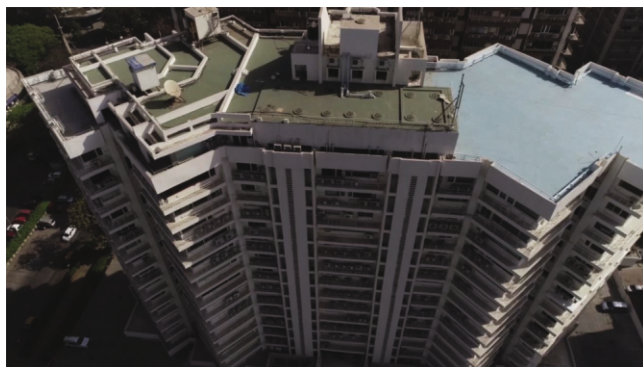
Fig 13: Final finish of terrace after application of Polyurethane coating on top.

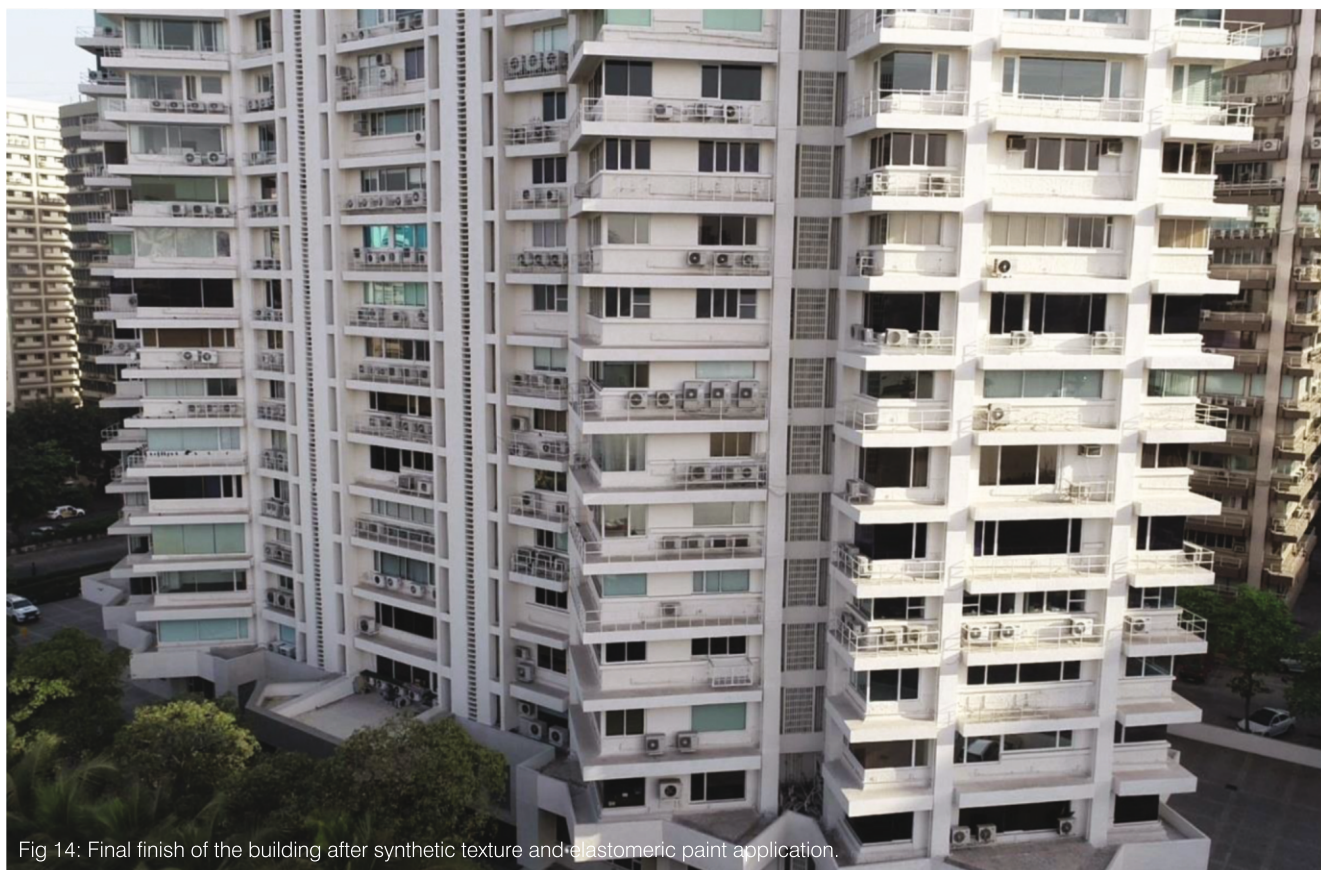
Fig 14: Final finish of the building after synthetic texture and elastomeric paint application.

14. Synthetic texture of upto 2mm and specialized elastomeric coating of 250 micron was applied over the exterior facade to give it a uniform look. The elastomeric coating used had alkaline & anti-carbonation properties of upto 558 mtrs which are generally used on road and sea bridges.

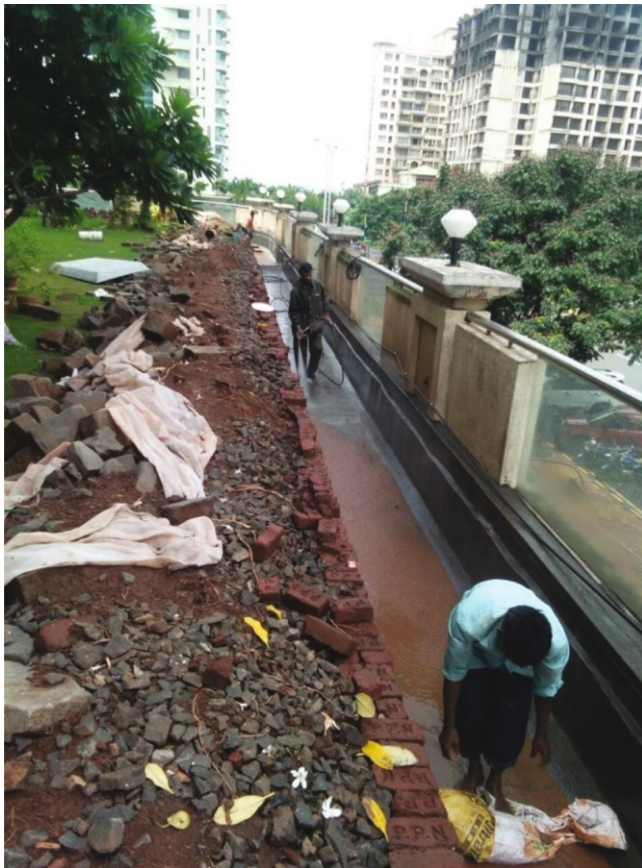
Fig 3: Removing the soil excavation above the shops/parking garage to do cleaning followed by repair & waterproofing.

Treatment: The garden area and the chambers near the swimming pool which were seeping leakages down to the parking/shop area were carefully excavated till the surface level by clearing away vegetation trees of all girth, bushes, underground roots including shoring, strutting and all safety provisions, by providing adequate slopes for drains. After proper washing/cleaning the surface, the cracks were sealed with dual component epoxy injection resin mortar grout. The unsound concrete was also repaired/replaced by new mortar with proper slope provision and drain system to maintain proper water flow.

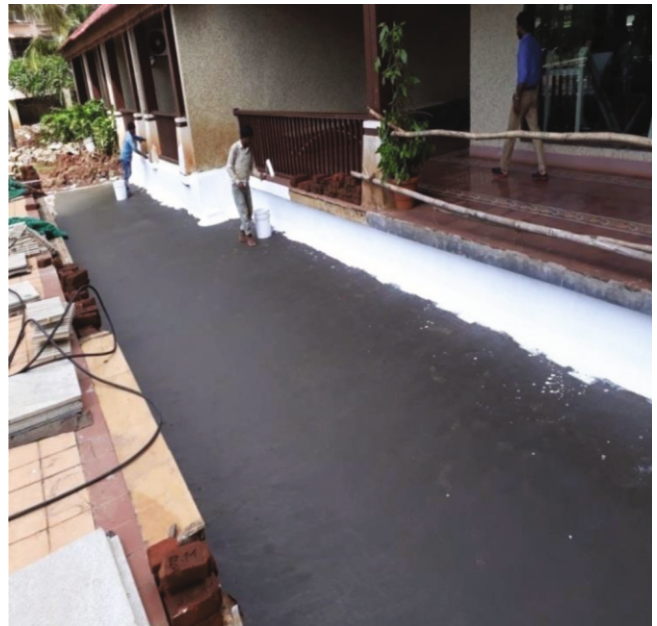
Fig 4.1: Surface after proper cleaning, grouting, laying of mortar to maintain proper slope followed by application of PU Coating

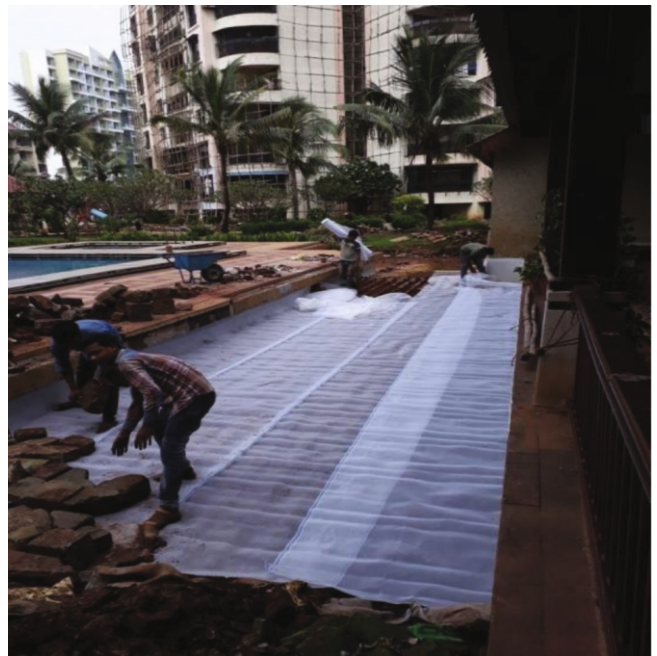
Fig 4.2: Laying geotextile fabric to protect the coating from getting damaged by the further covering of soil.

A single component polyurethane coating with anti root properties was then applied on the ready surface and carefully protected with geo-textile fabric mesh of 80 Gsm to prevent waterproofing treatment from getting damaged. The surface was then backfilled with earth, soft/weathered rock, which includes boulders/ slag/slate /laterite and gravel/ clay thoroughly filled with good quality murum of all kinds, rubble, concrete debris using hard barricading as per OWNER's standards to re achieve the desired garden surface.

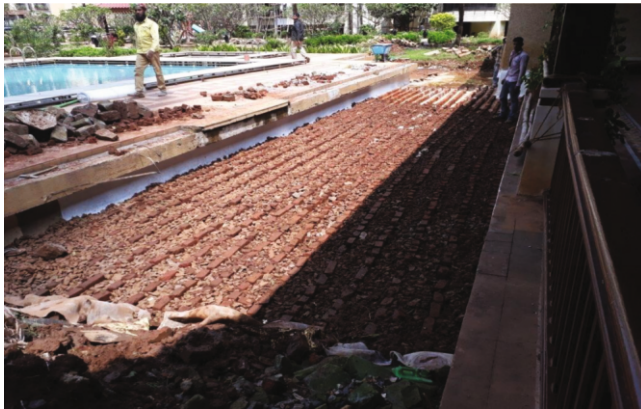
Fig 4.3: Laying & backfilling the soil with layer of earth, rocks and good quality rubble to achieve the garden surface.

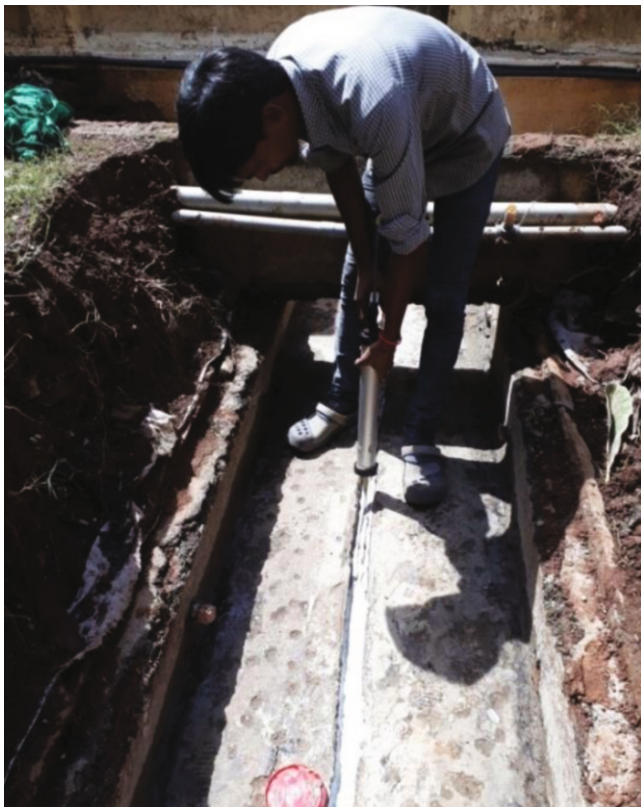
Since, the expansion joints had rendered rigid due to cement mortar/concrete/soil-topping fills leading to stress build up in adjacent beams/columns/brackets which not only led to severe cracking in these structural members but also had a bearing on the stability of building structure. Also, cursory inspection of expansion joints at some locations indicated that the filler material in the joints has lost its efficacy as the material inserted was fully eroded. Apart from resulting in a loss of movement accommodation capacity of the joints, the joints had become vulnerable to leakages below.

Fig 5.1: Filling of PU Sealant

Treatment: The grooves in the expansion joints were carefully opened followed by removing the rigid materials from the joints. The opened joints was thoroughly cleaned and fixed with back up rod to required depth thereafter filling up with compressible and flexible single component moisture

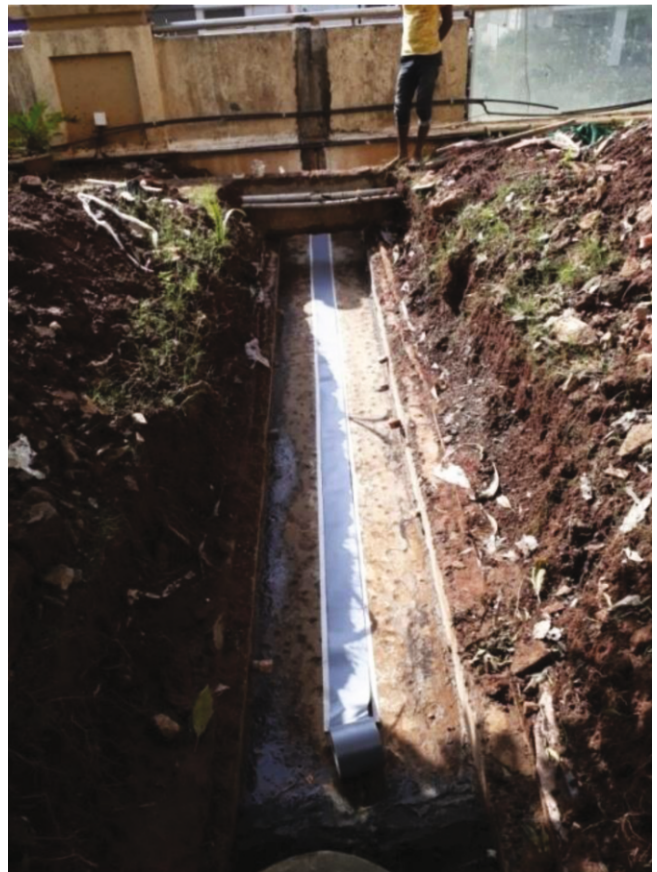
Fig 5.2: Laying expansion joint sealing membrane to protect the sealant.

curing polyurethane construction sealant material upto required depth to provide a non-slump elastomeric seal and good weathering characteristics. After carefully sealing the joints, the surface was further covered with a highly elastic, rot-proof and chemically resistant sealing membrane which comes with a two part epoxy compound & establishes a strong bond to various types of substrate. Final covering of sealing membrane was topped by polyurethane coating & fabric protection to receive earth backfilling.

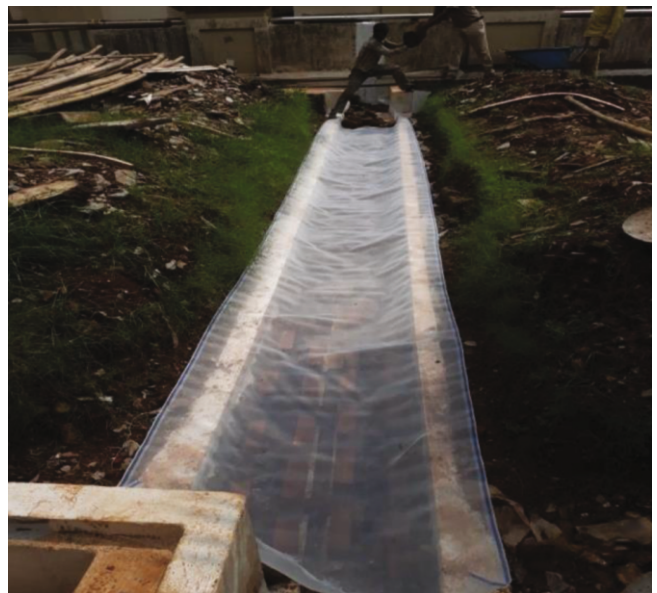
Fig 5.3: Laying Geotextile mesh to protect the joints and waterproofing done.

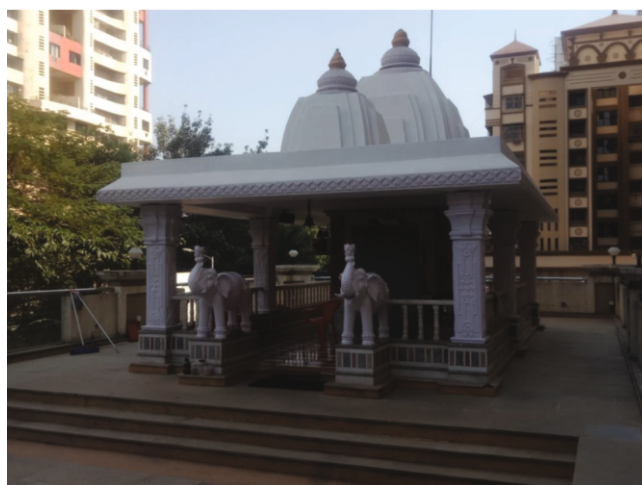
Fig 7: After filling the joint and applying protective coating.

Treatment: Entire joints on the stone were carefully opened with mechanical grinder without undue damage to the stone and filled with a flexible polysulphide sealant to allow for expansion and contraction of the stone slabs that can experience 70 °F (20 °C) temperature differentials in 24 h cycles. The top of the marble was coated with clear protective coating to maintain the beauty of the stone and make it water-proof.

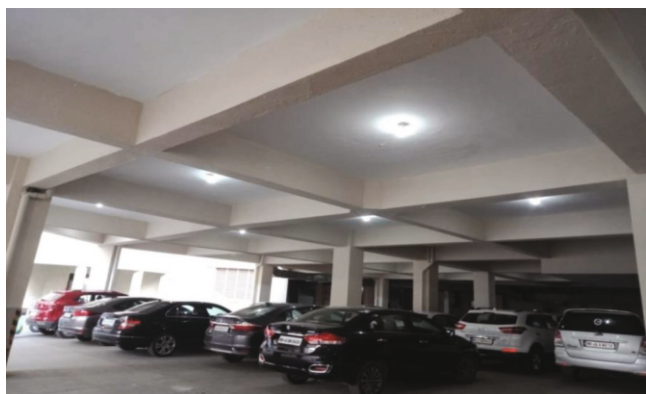
Fig 9: After final completion of work

- c) Further, a single component trowelable polymer mortar which had a dual shrinkage compensated, fibre reinforced thixotropic high strength formulation was used for the repairs of RCC members/columns where the thickness was within 25mm and upto 45 mm.
- d) The surface was then rendered with ready mix cement plaster overlays in two coats with a smooth finish. The concrete layer was cured for 10 days by continuous wetting through a sprinkler system.
- e) Lastly, an elastomeric protective coating of 250 micron thickness was applied over the exterior facade & col-

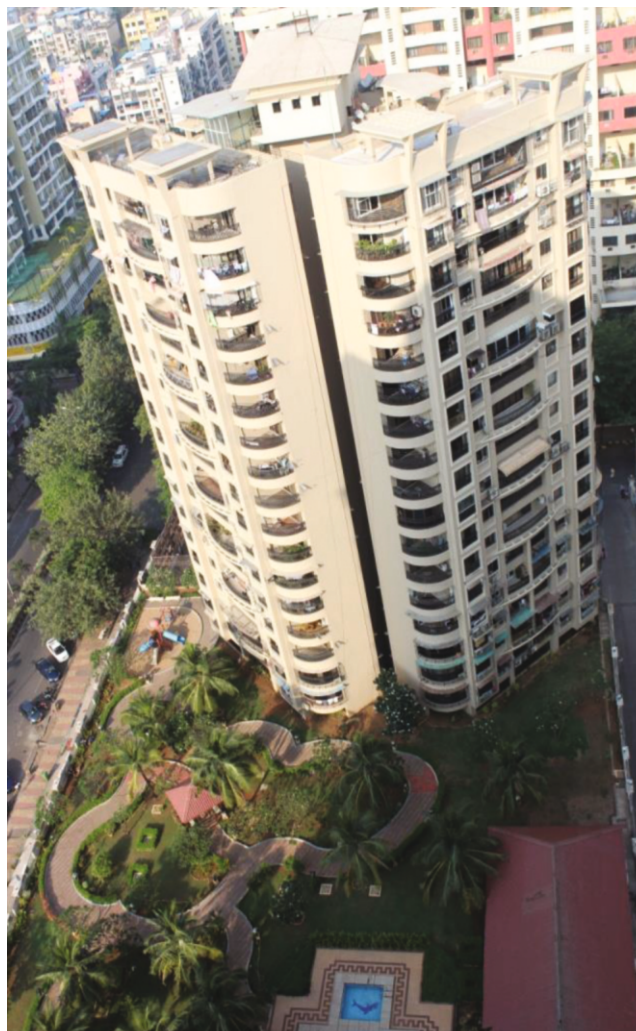
Fig 10: Birds' eye view of the Podium & Parking Garage.
